# Conversion of a natural gas pipeline to hydrogen transport and the effects of impurities on the hydrogen quality

ENTSOG GAS QUALITY & HYDROGEN WORKSHOP

Henk Top – DNV New Energy, Groningen, The Netherlands

07 November 2022

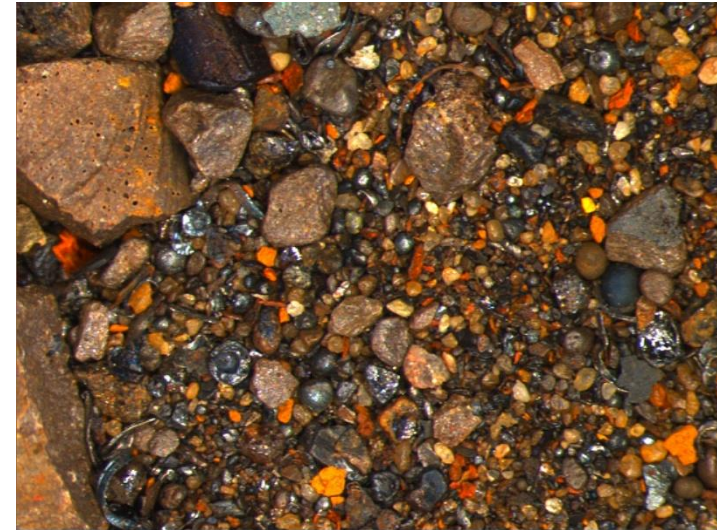
# SEM-EDX analysis debris

Scanning Electron Microscope (SEM)-Energy-Dispersive X-ray (EDX) results:

- Minerals
- Rust particles
- Iron oxide balls (welding and grinding)
- Chips of low alloy steel

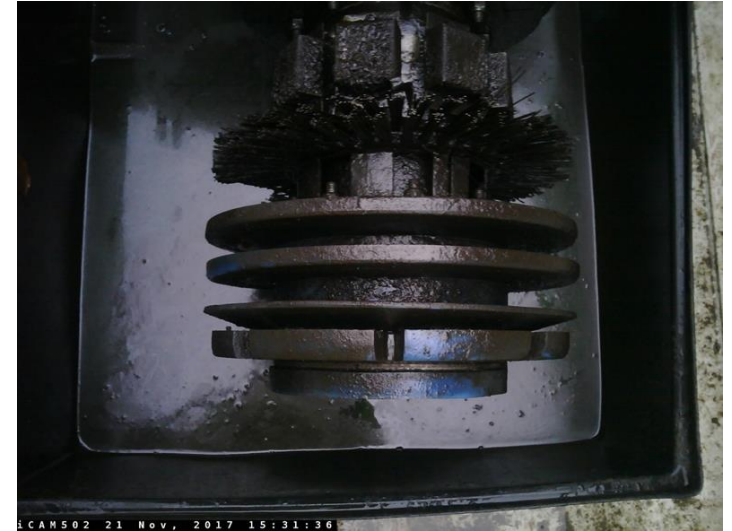
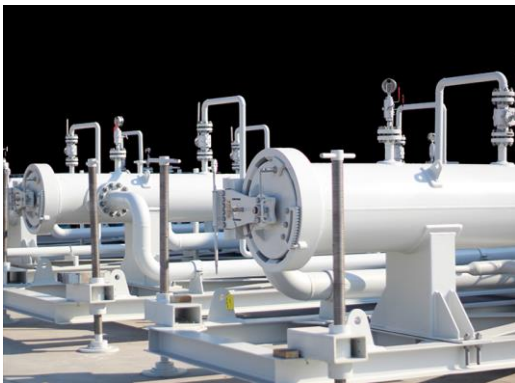
Photo: Pig launcher/receiver Ergil

The existing 16-inch section of the natural gas pipeline was examined using internal Magnetic Flux Leakage (MFL) inspection in 2017. This is a widely used non-destructive testing method for the detection of (internal) corrosion and pitting in steel structures. Before this inspection the natural gas pipeline was cleaned by means of a bi-directional (BIDI) cleaning pig. Approximately 5 litres of sludge (not analysed) came along at that time. Sludge found in natural gas pipelines normally consists of a mixture of natural gas condensates, lube oil and glycol.

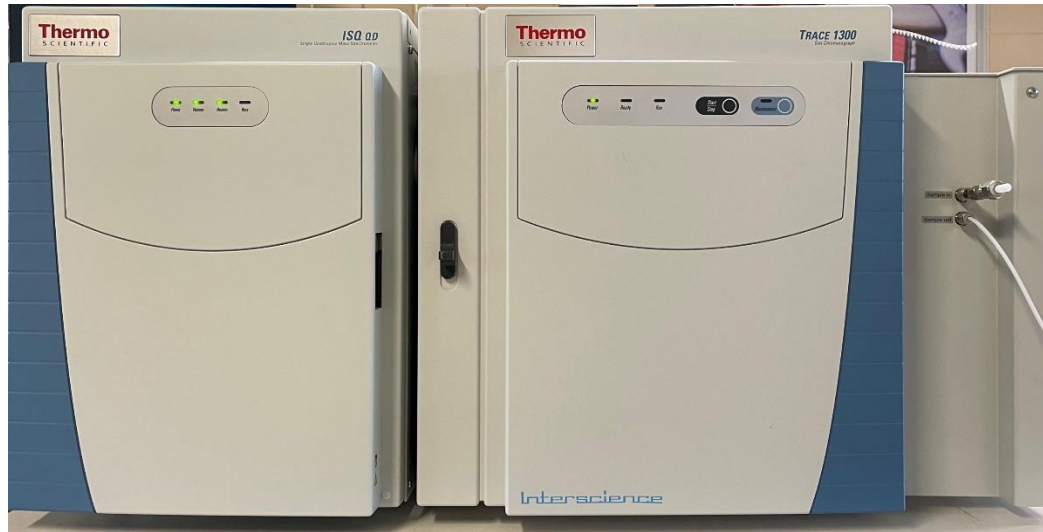
GC/MS system DNV, delivered by Interscience

Thermo Scientific Trace 1300 Gas Chromatograph with a Flame Ionisation Detector and a Mass Spectrometer ISQ (single quadrupole) in parallel

Screening unknowns in mass range 20 – 400 amu

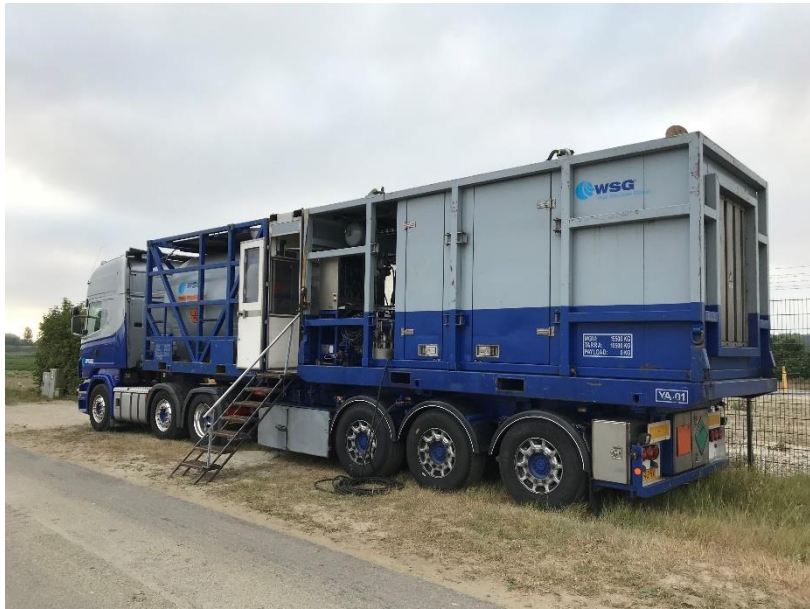
Nitrogen unit WSG

Following an investigation into the residual products in the converted pipeline, which will eventually transport hydrogen, it was found that a number of components have relatively high values. It was decided to purge with nitrogen at one side and to vent it on the other side of the former natural gas pipeline. DNV was asked to monitor this process using a water dewpoint sensor, a flame ionization detector ( $C_xH_y$ ) and a micro-GC.

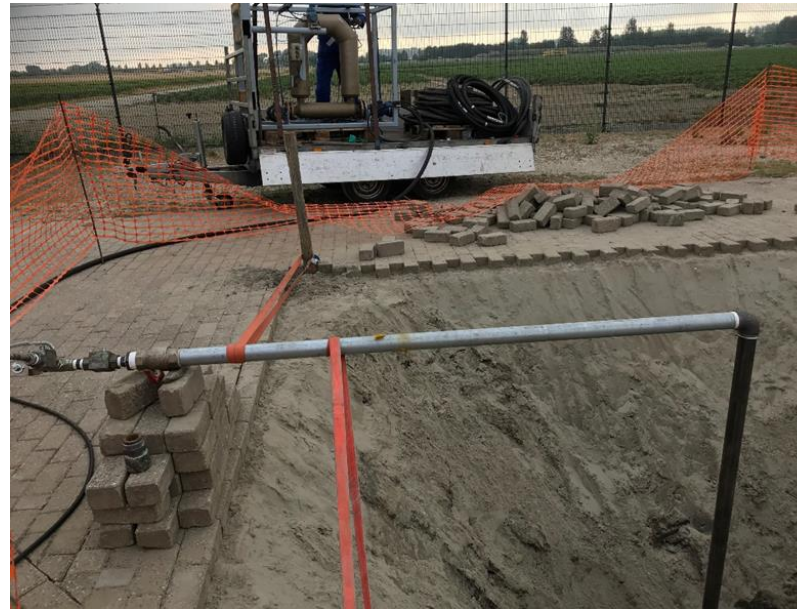
Nitrogen injection DN50 + Coriolis flowmeter

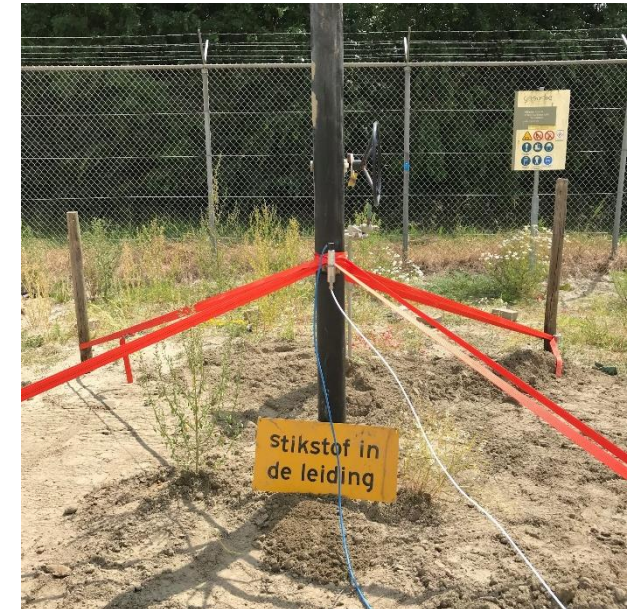
Nitrogen vent DN100 + sample point DNV

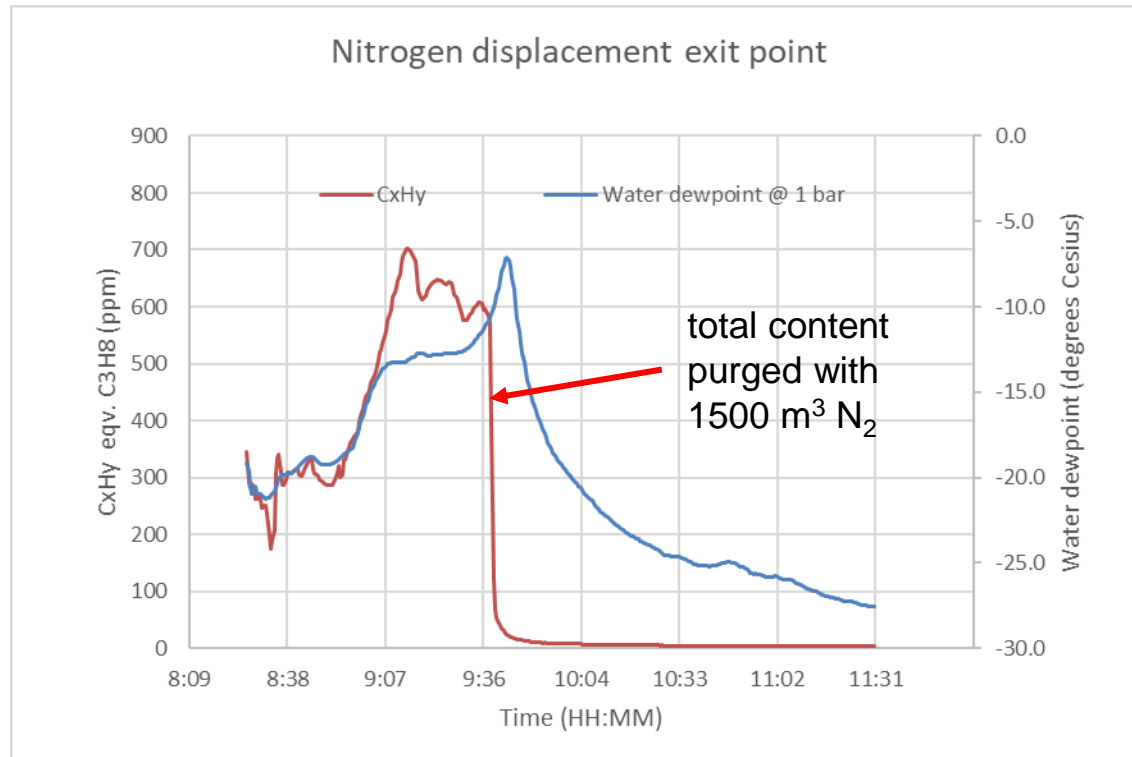
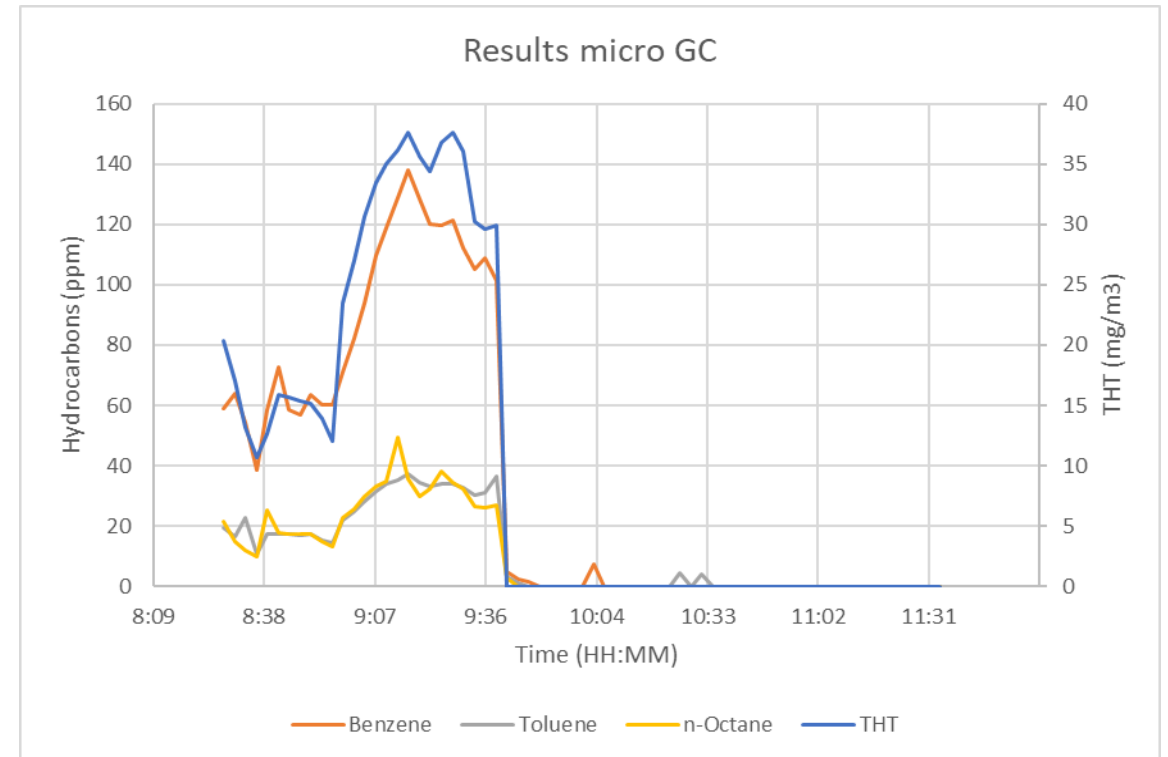
# Nitrogen purge results July 2018 (1)

The initially measured high concentrations of contaminants (aromatics and THT) in the nitrogen originated from pores in the inner wall (flow coating) of the former natural gas pipeline. Because the pipeline had been stored under nitrogen for several weeks, the nitrogen was slowly contaminated because of desorption. This same effect could be observed on a shorter time scale after the initial nitrogen displacement. The concentration of hydrocarbons increased from a concentration of 3 ppm to 7 ppm over the entire length of the pipeline within three hours.

1. Initially the natural gas in the 12 km long pipeline was displaced with nitrogen in 2018. After an additional purge in July 2018, the concentration of contaminants decreased very rapidly from 600 ppm  $C_xH_y$  to 3 ppm  $C_xH_y$ . The initially measured high concentrations of contaminants (aromatics and THT) originated from pores in the inner wall (flow coating) of the former natural gas pipeline. Because the pipeline had been stored under nitrogen for several weeks, the nitrogen was slowly contaminated because of desorption. This same effect could be observed on a shorter time scale after the initial nitrogen displacement. Indeed, the concentration of hydrocarbons increased from a concentration of 3 ppm to 7 ppm over the entire length of the pipeline within three hours.

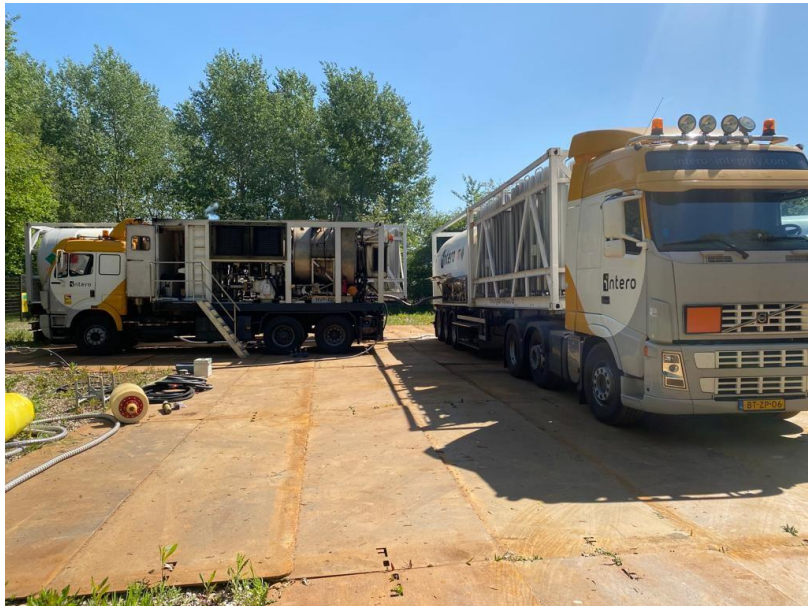
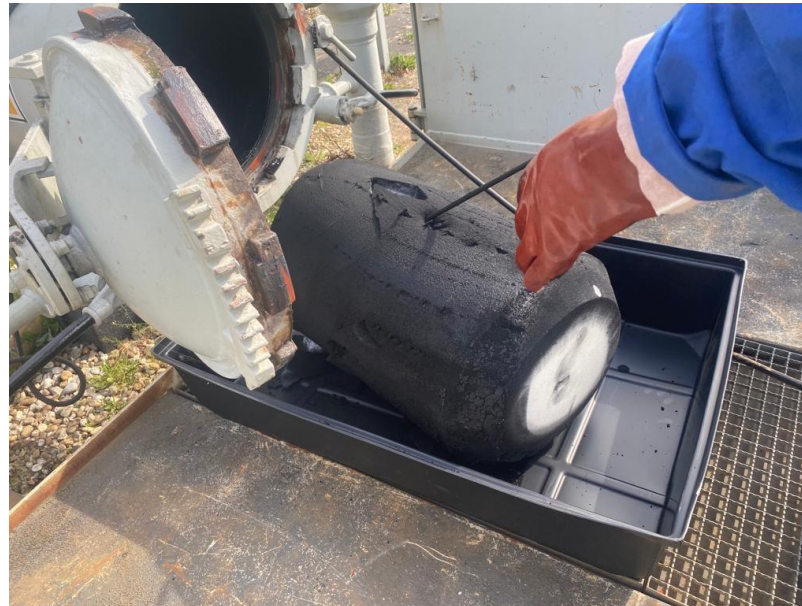
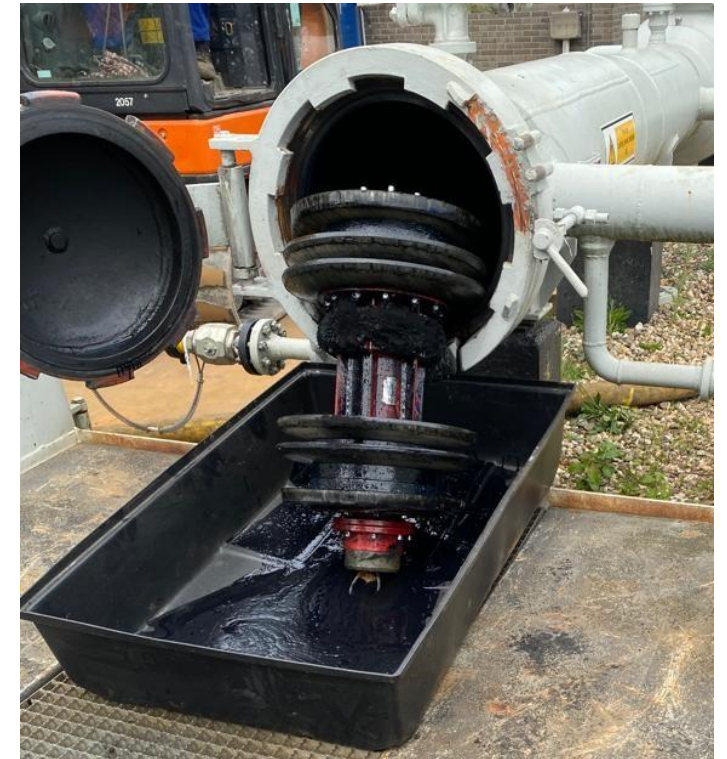
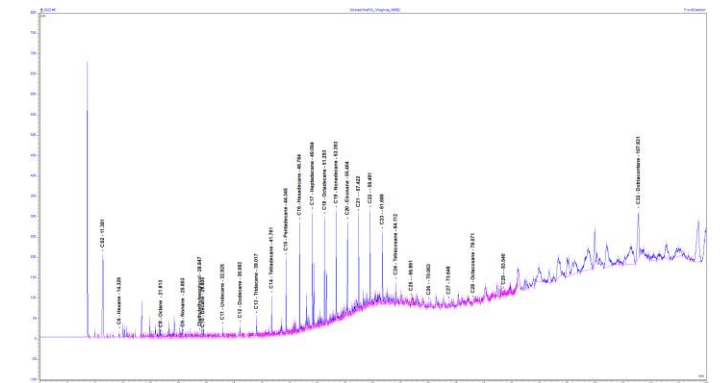
# Nitrogen purge A-582, May 2022

22.3 km long 18 inch natural gas pipeline Vliegghuis - Zwartemeer

5,000 m<sup>3</sup> nitrogen used for single purge  
3 liters sludge (oil + black powder)

2. After about five displacements with pure nitrogen in July 2018, the concentrations of almost all contaminants are well below the Hynetwork hydrogen specification. Purge of May 2022 gave similar results.

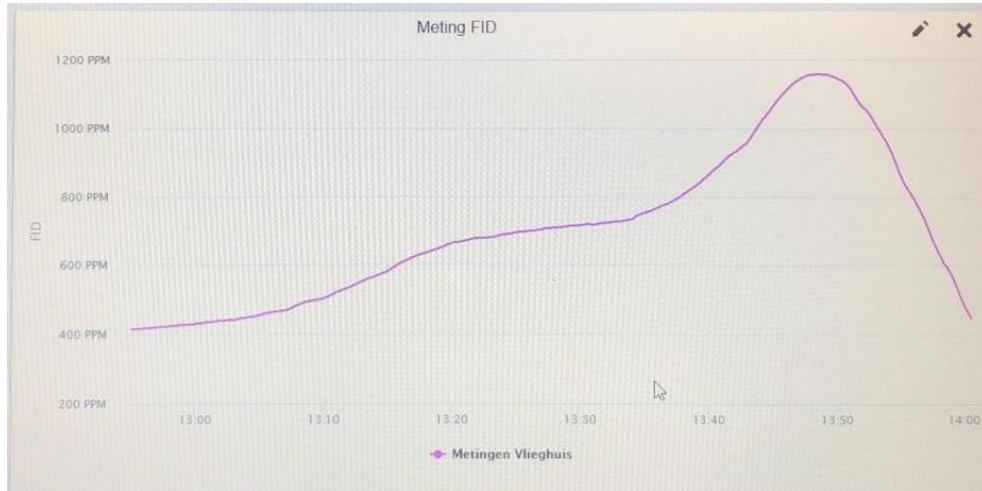
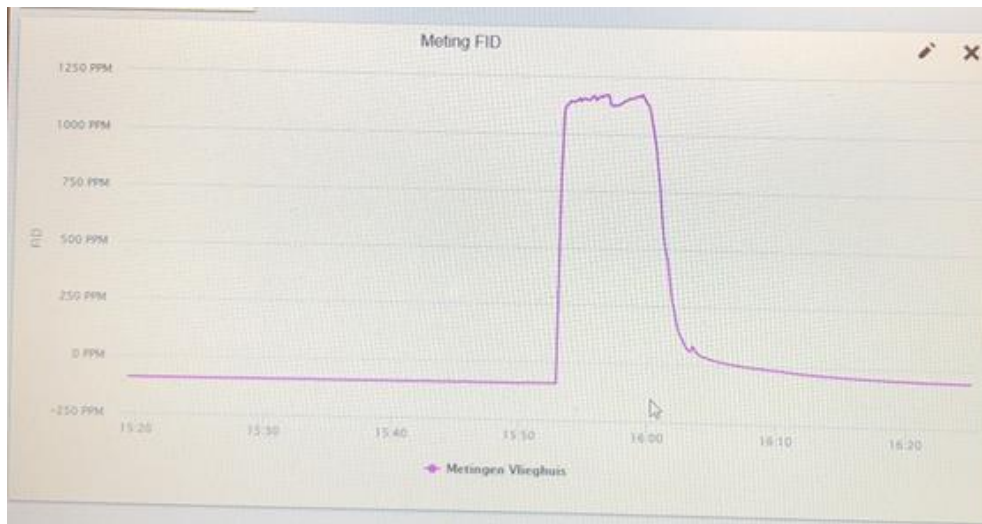
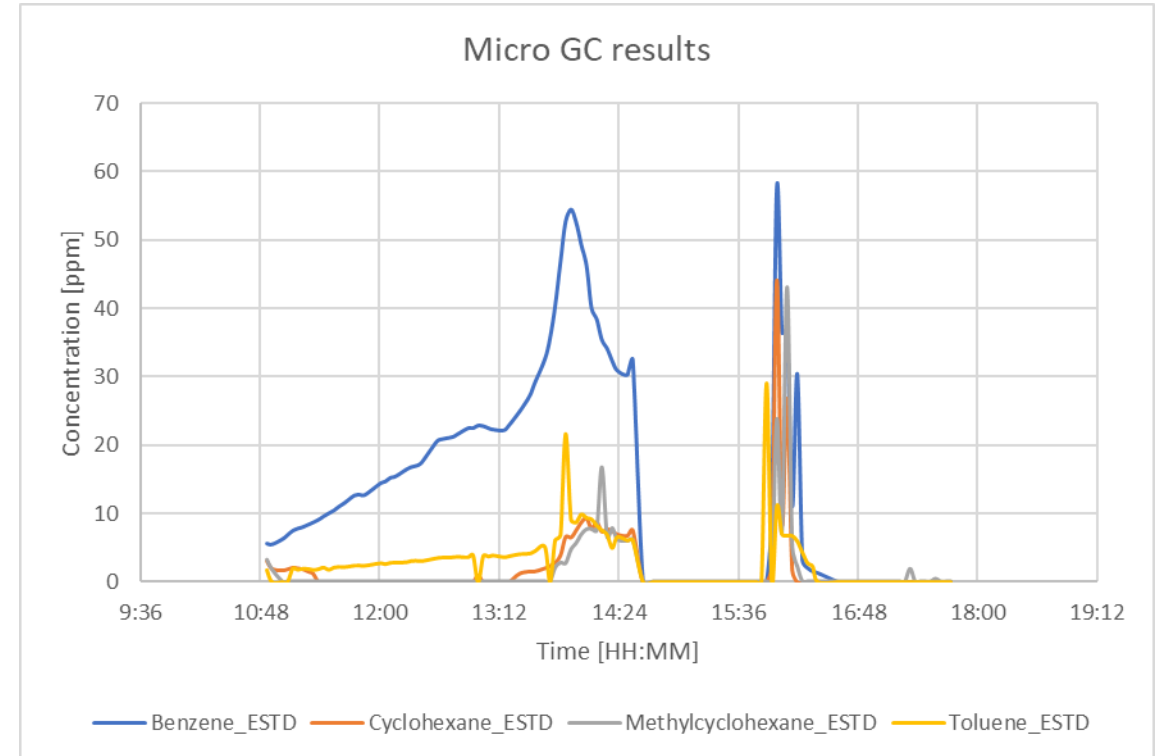
# Hydrocarbons A-582 nitrogen purge

July 28 2022:  $C_xH_y$  110 ppm
